Manhole Inspection Summary

Manhole # S710__004MH

Insp Date: **2/4/08 9:58 AM**

Location Address: **1300 Bethlehem Ave.**

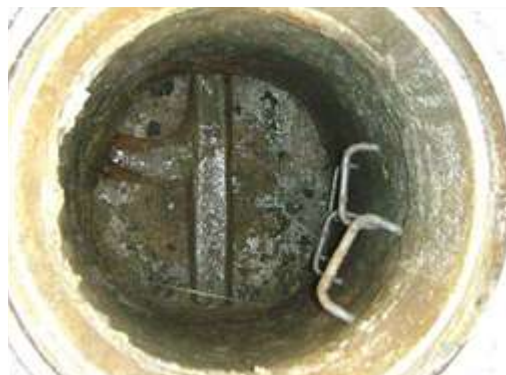
Top View

Condition: ☐ Sound ☐ Cracked ☐ Root Intrusion ☐ Deteriorated ☐ Leaks ☒ **Debris**

Count: **5** Missing: **0** ☒ **Corroded**

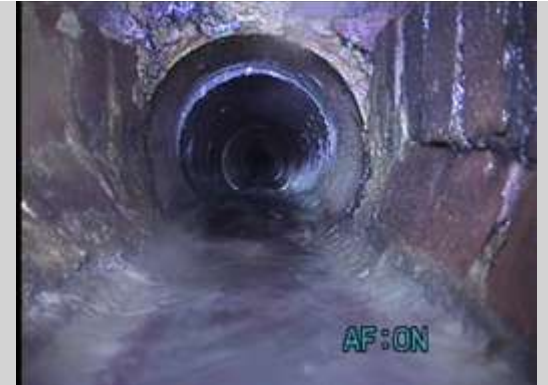
12 O'Clock Outflow

8 in. Circular Gravity Sewer
Pipe Out @ 12 O'Clock

Pipe Height: **8.4** (in.) Rod and Bar (Angled)
Pipe Material: **Clay** ☐ Pipe Lined
Invert Depth: **10.75** (ft.) Flow Characteristics: **Fast**
Deposits: ☒ None ☐ Mud ☐ Sludge ☐ Debris ☐ Grease
Silt Depth: (in.) Deposits Extent:
Infiltration: **None** Pipe Seal Cond: **Sound**

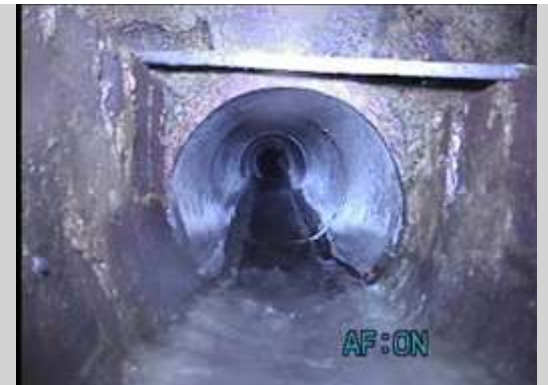
6 O'Clock Inflow

8 in. Circular Gravity Sewer
Pipe In @ 6 O'Clock

Pipe Height: **8.4** (in.) Rod and Bar (Angled)
Pipe Material: **Clay** ☐ Pipe Lined
Invert Depth: **10.67** (ft.) Flow Characteristics: **Fast**
Deposits: ☒ None ☐ Mud ☐ Sludge ☐ Debris ☐ Grease
Silt Depth: (in.) Deposits Extent:
Infiltration: **None** Pipe Seal Cond: **Sound**

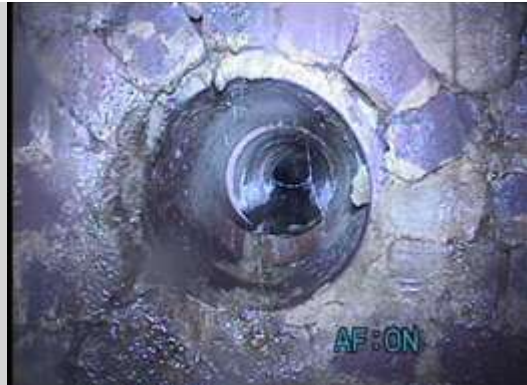
9 O'Clock Inflow

6 in. Circular Gravity Sewer

Pipe In @ 9 O'Clock

Pipe Height: **6** (in.) Rod and Bar (Angled)

Pipe Material: **Clay** ☐ Pipe Lined

Invert Depth: **8.58** (ft.) Flow Characteristics: **Slow**

Infiltration: **None**

Pipe Seal Cond: **Sound**

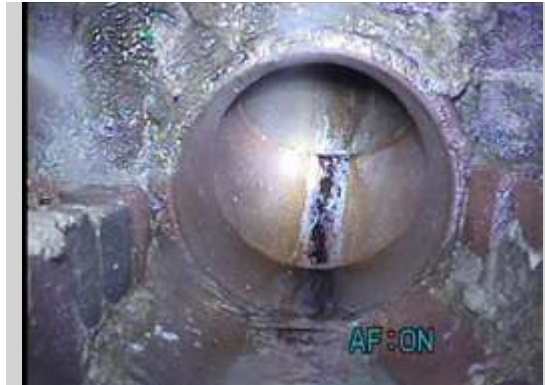
Drop In @ 9 O'Clock

Drop: **Outside** Rod and Bar

Angled: **Yes** Reading: **9.33** (ft.)

Inv Depth: **10.33** (ft.)

Drop Condition: **Open**

Connects To: **House connection / Service line**
